AIR SERVICE INFORMATION CIRCULAR

December 1, 1922

STATIC TEST OF THE DAYTON WRIGHT TA-3 AIRPLANE

Prepared by A. L. Morse
Engineering Division, Air Service
McCook Field, Dayton, Ohio
July 15, 1922

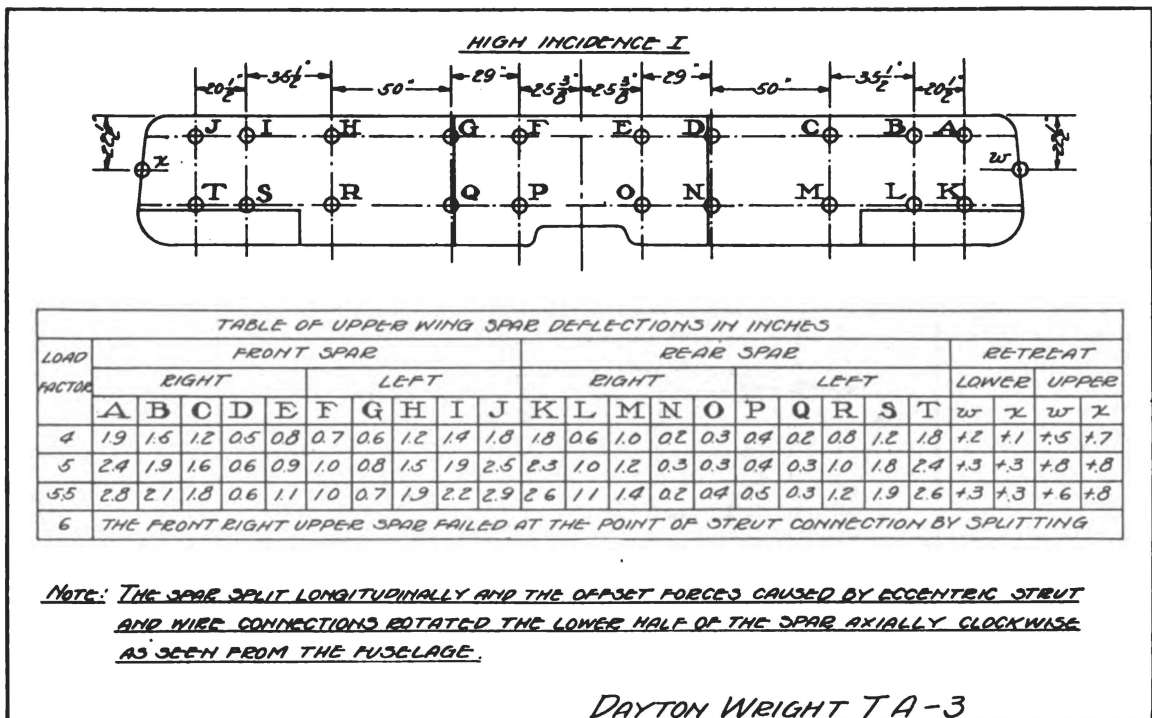
FIG. 12.

of the failure. Figure 12 is a table of spar deflections and Figure 13 shows the deflection curves.

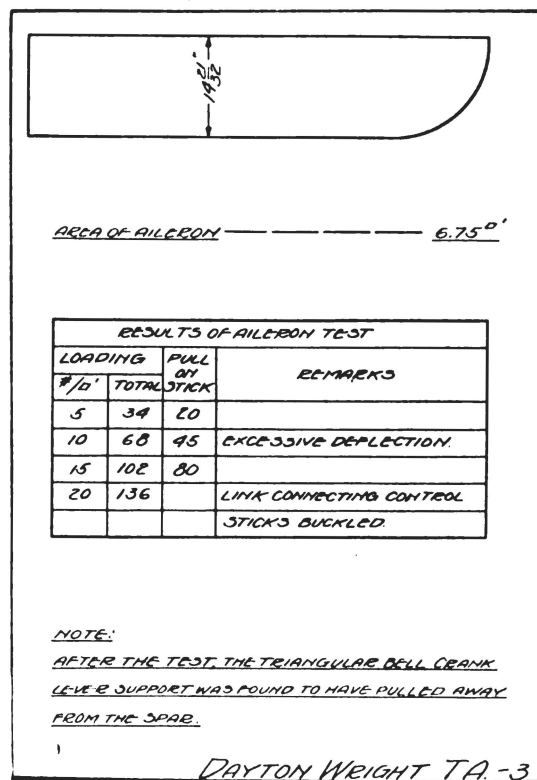
FIG. 23.

Figure 23 shows the results of the test. At a load of 10 pounds per square foot there was an excessive deflection in both ailerons. At a load of 20 pounds per square foot the link connecting the twin control sticks buckled. Figure 37 is a photograph of the failure of the connecting link. The triangular bell-crank lever support pulled away from the spar. Figure 38 is a photograph of this failure.

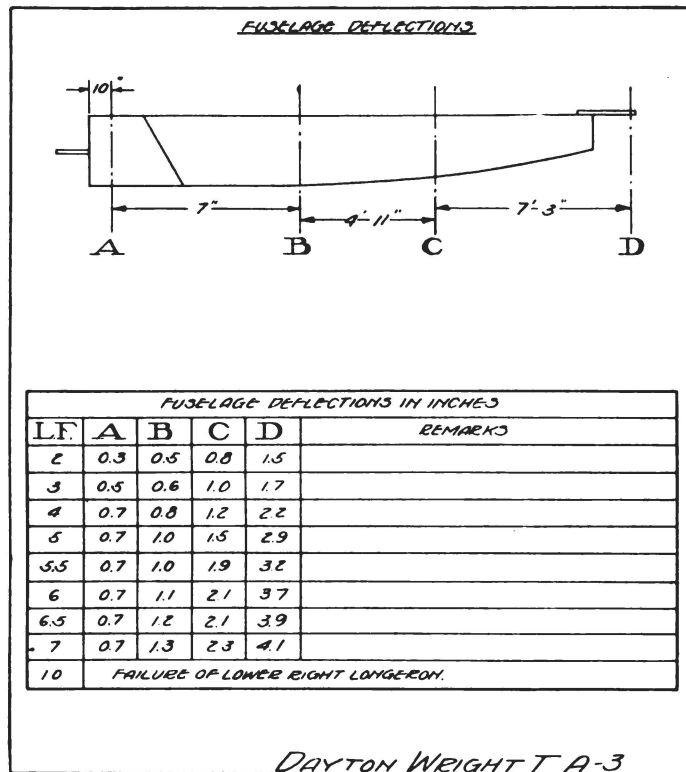
FIG. 26.

The fuselage failed at a load factor of 10. The lower right longeron two bays back of the cockpit failed by buckling. Figure 26 shows the results of the fuselage test. Figure 40 is a photograph of the longeron failure.

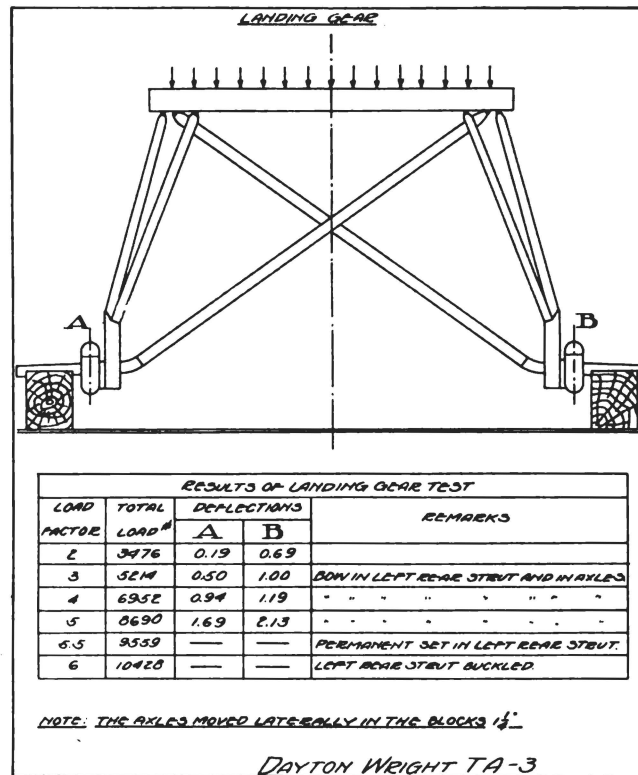
FIG. 29.

The landing gear failed at a load factor of 6. The left rear strut buckled. As the shock absorbers deflected the axles moved laterally in the cradles $1\frac{1}{4}$ inches. The results are tabulated in Figure 29. Figure 41 is a photograph of the failure.
